Project: **Re-roofing works, St James CE Church, Brownhills**

Title: **Roof inspection**

Date: **June 2023**

Document ID: **1871-17**

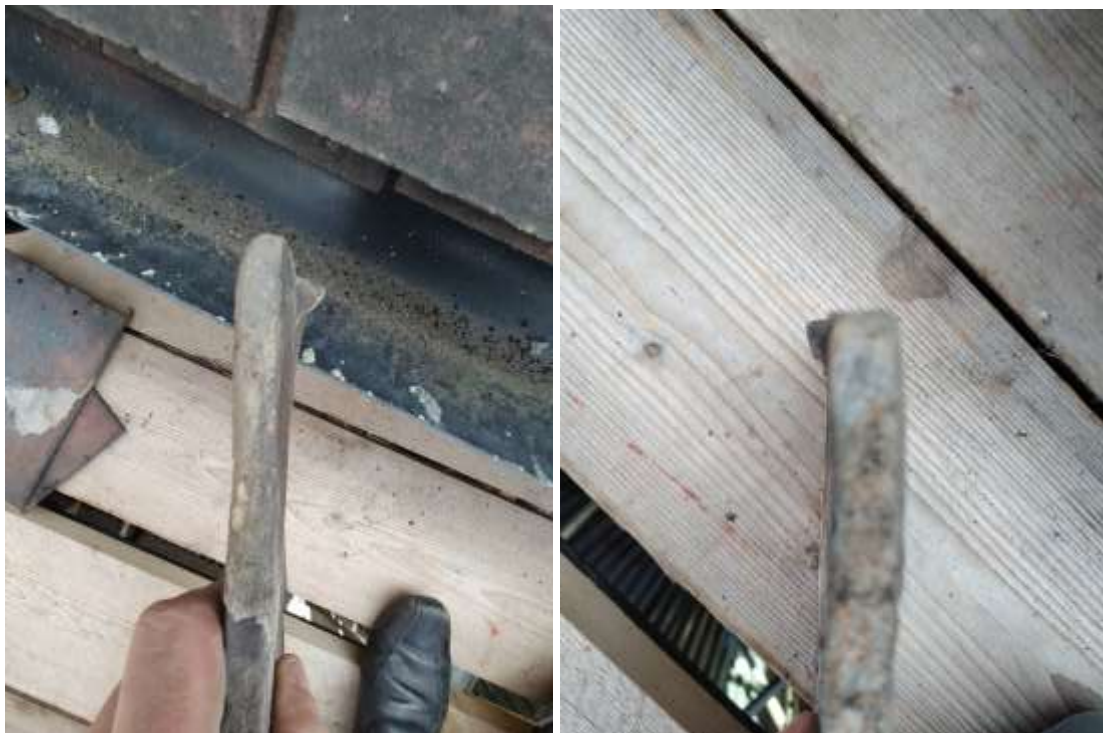
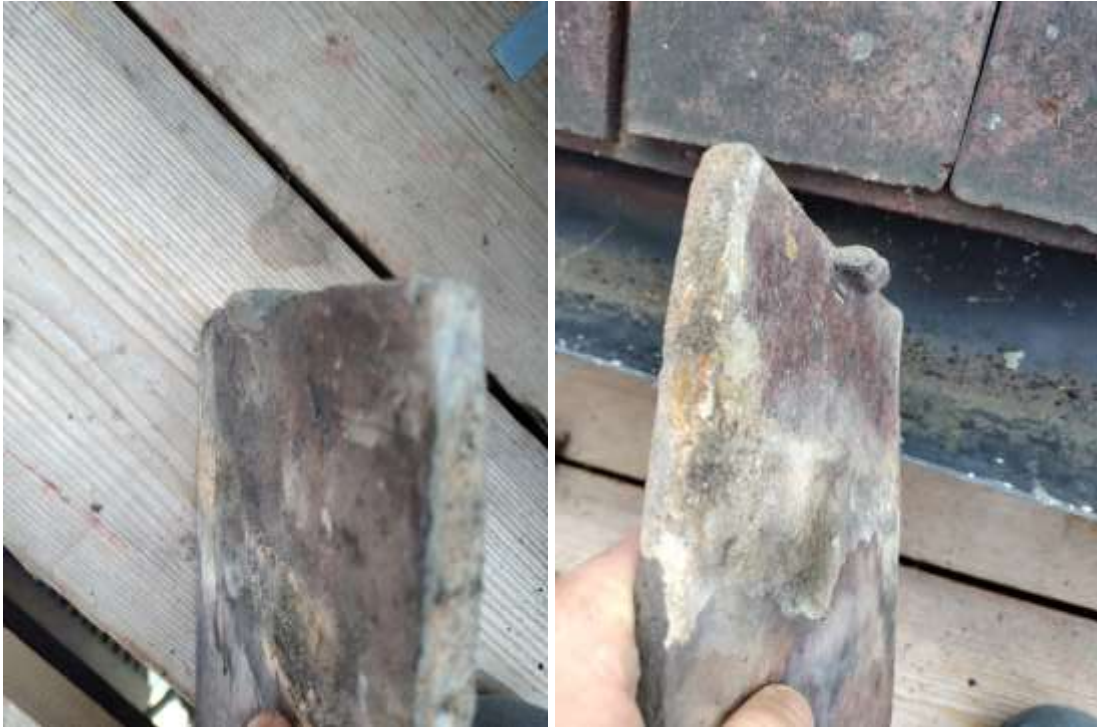
The overwhelming majority of the tiles are handmade clay tiles with a single nib, which appear to have been reclaimed from elsewhere (the staining on the tiles suggests that they were originally 'torched' (bedded in mortar) as they were laid, however none of this torching was present. These handmade tiles also did not appear to have any nail holes and from the sample locations it seemed that only one tile in every twelve courses had been nailed with a single nail (presumably using a drilled hole). This is a long way short of the current British standard of two nails in each tile of every fifth course.

Whilst the single nib is nowadays considered as insufficient in its own right, the shape of the nibs themselves was very inconsistent amongst the sample group (see photos).

Some had a very pronounced nib, whereas many had a malformed nib. Two or three did not seem to have much of a nib at all and will have only been relying on friction and the weight of the tile above to keep them in place. The nib defect would explain the very sporadic way in which tiles have been falling.

In terms of conclusion, it would seem necessary to replace the roof tiles with new tiles having both a minimum of 2No. nail holes pre-formed and a minimum of 2No. hanging nibs on the rear. Existing battens and felt appear to have plenty of life left, however, given that the battens are now considered undersized to current standards and for warranty purposes the PCC have indicated their approval to replace felt and battens as well as tiles.
